REPORT NO: 2418-1697

**PRELIMINARY GEOTECHNICAL REPORT
DESKTOP STUDY
PROPOSED ROYAL CUBERA LASP
41 AVENUE SW(EDMONTON) & RANGE ROAD 243
PART OF SECTION 9-51-24-4
COMMERCIAL / INDUSTRIAL DEVELOPMENT
LEDUC COUNTY, ALBERTA**

November 2012

**J. R. Paine & Associates Ltd.
17505 - 106 Avenue
Edmonton, Alberta
T5S 1E7**

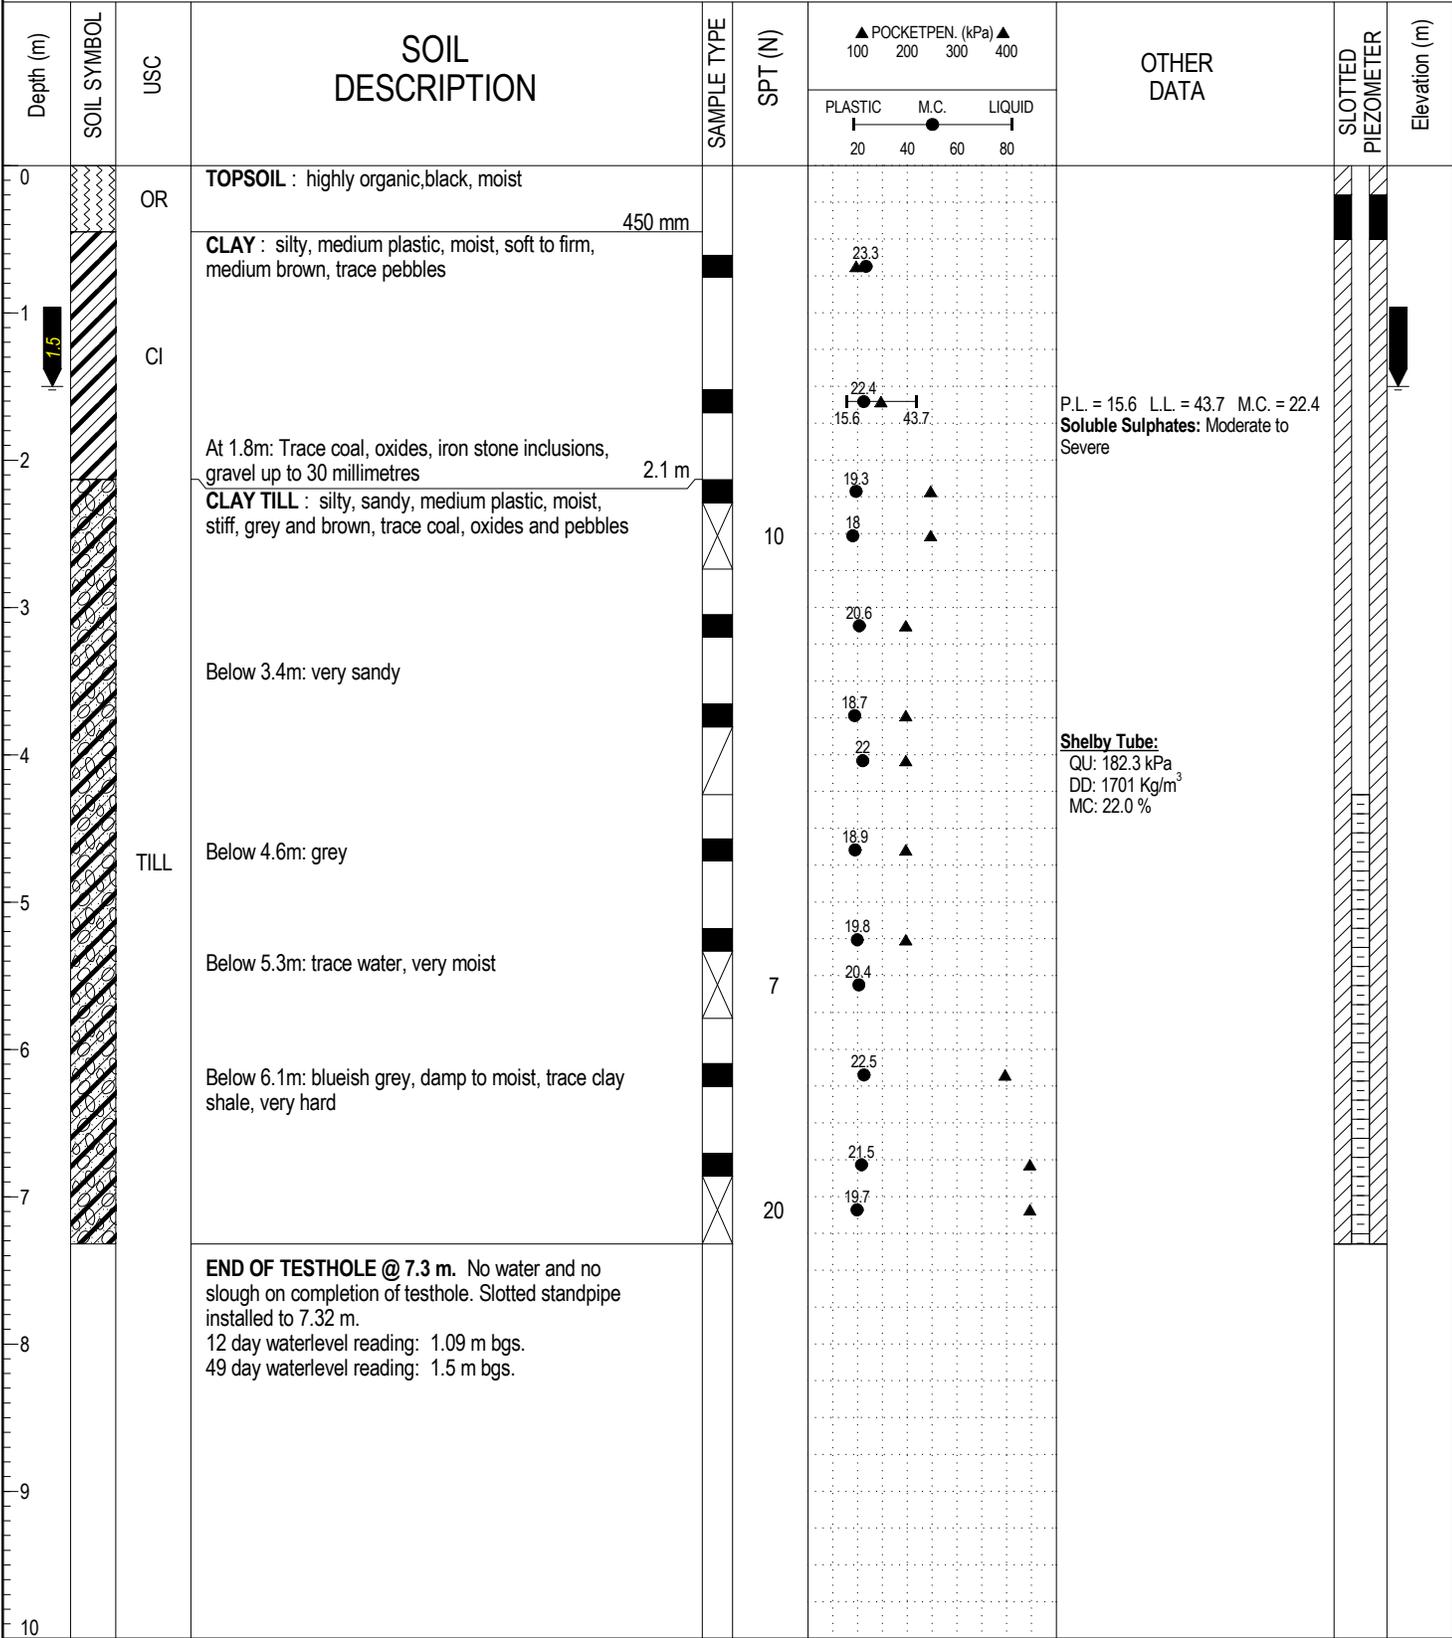
LOGGED BY: Scott MacFarlane
REVIEWED BY: R Evans
Fig. No: 07-1

PROJECT: Preliminary Geotechnical Assessment, N1/2 SE 9-51-24-W4M		PROJECT NO: 1166-274	BOREHOLE NO: 07-1
CLIENT: Qualico Developments West Ltd.		DRILL METHOD: Solid Stem Auger	ELEVATION:
OWNER:		LOCATION: As per site plan	
SAMPLE TYPE	<input checked="" type="checkbox"/> SHELBY TUBE	<input checked="" type="checkbox"/> CORE SAMPLE	<input checked="" type="checkbox"/> SPT SAMPLE
	<input type="checkbox"/> GRAB SAMPLE	<input type="checkbox"/> NO RECOVERY	
BACKFILL TYPE	<input checked="" type="checkbox"/> BENTONITE	<input type="checkbox"/> PEA GRAVEL	<input type="checkbox"/> SLOUGH
	<input type="checkbox"/> GROUT	<input type="checkbox"/> DRILL CUTTINGS	<input type="checkbox"/> SAND

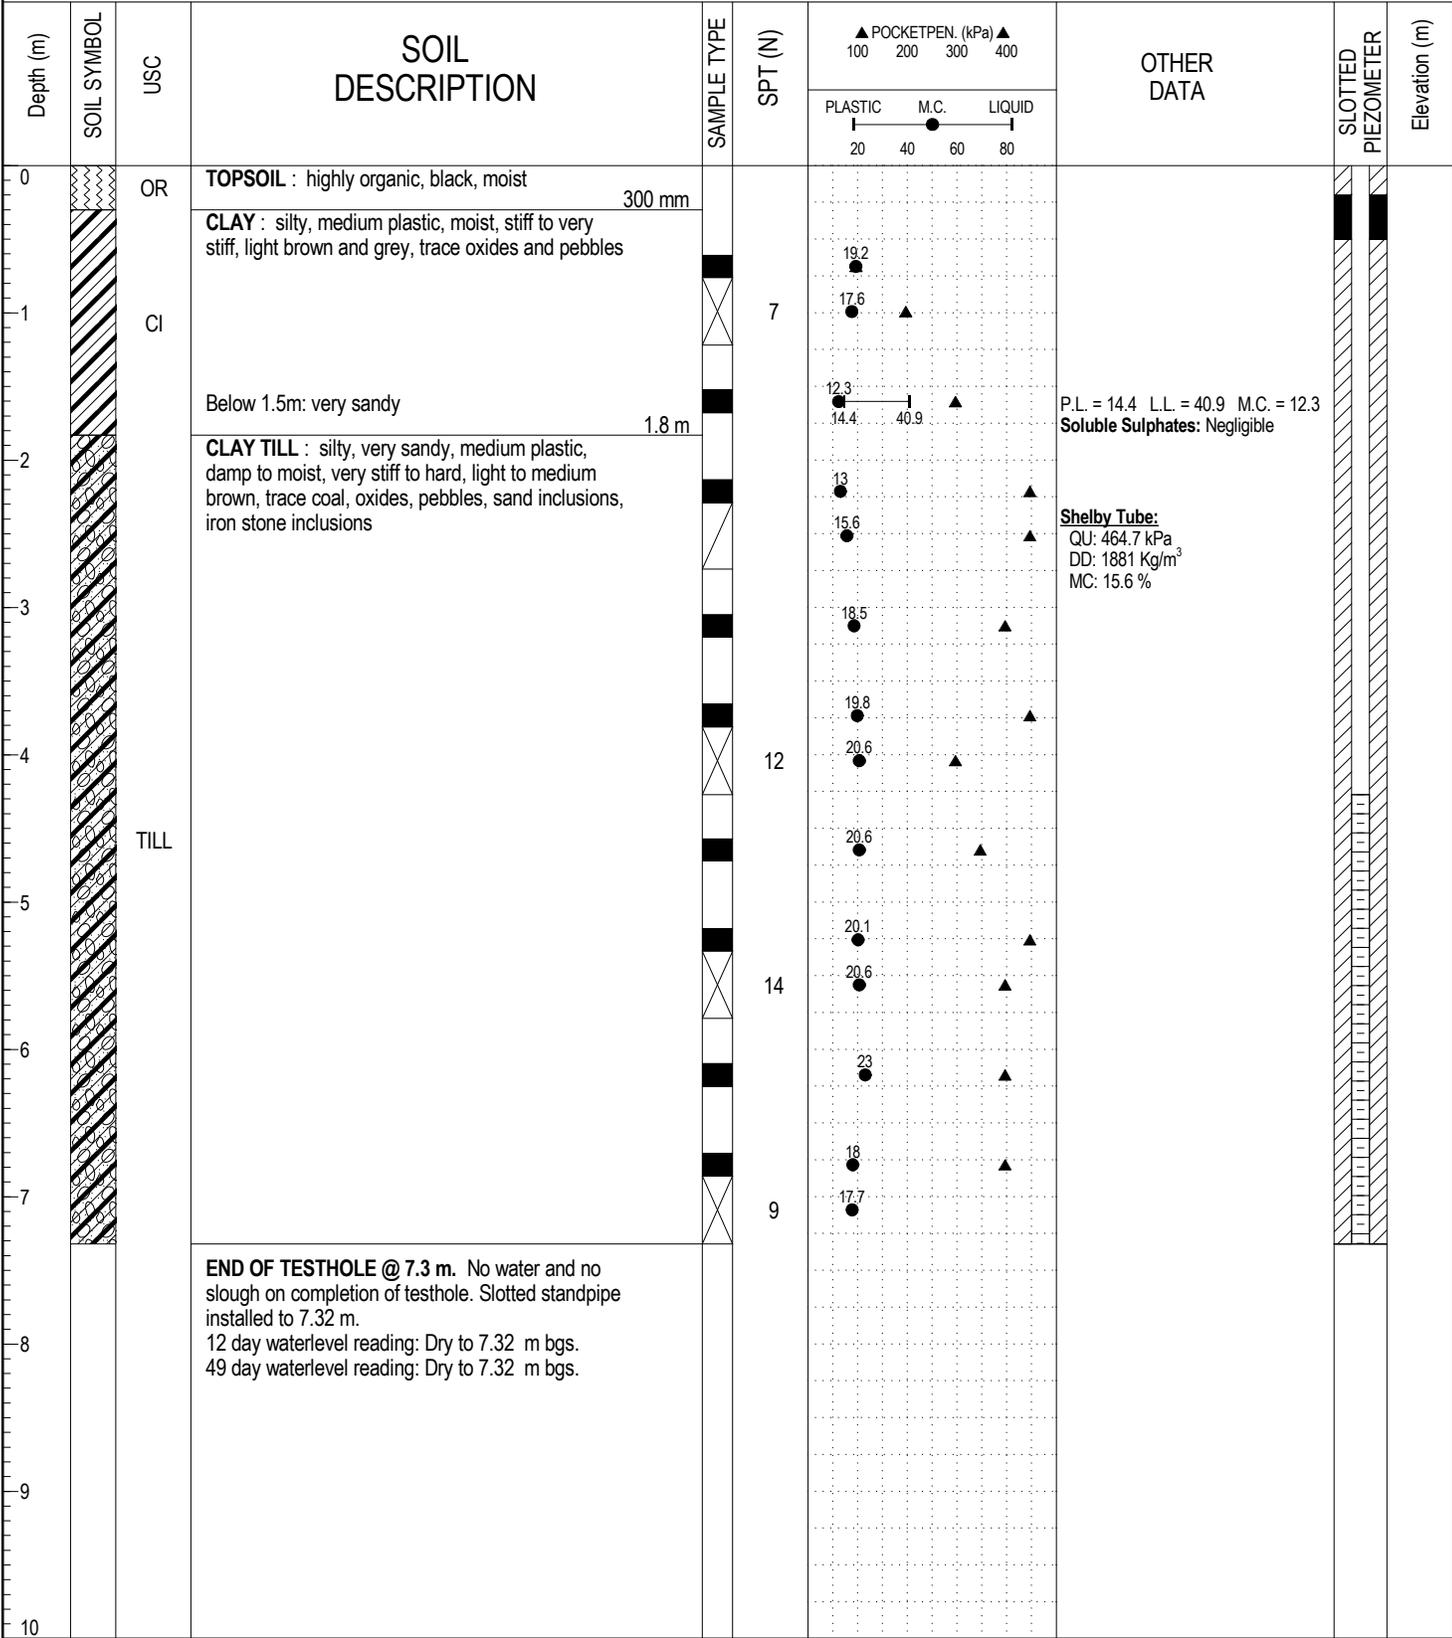
LOGGED BY: Scott MacFarlane
REVIEWED BY: R Evans
Fig. No: 07-2

PROJECT: Preliminary Geotechnical Assessment, N1/2 SE 9-51-24-W4M		PROJECT NO: 1166-274	BOREHOLE NO: 07-2
CLIENT: Qualico Developments West Ltd.		DRILL METHOD: Solid Stem Auger	ELEVATION:
OWNER:		LOCATION: As per site plan	
SAMPLE TYPE	<input checked="" type="checkbox"/> SHELBY TUBE <input checked="" type="checkbox"/> CORE SAMPLE <input checked="" type="checkbox"/> SPT SAMPLE <input checked="" type="checkbox"/> GRAB SAMPLE <input type="checkbox"/> NO RECOVERY		
BACKFILL TYPE	<input checked="" type="checkbox"/> BENTONITE <input type="checkbox"/> PEA GRAVEL <input type="checkbox"/> SLOUGH <input type="checkbox"/> GROUT <input type="checkbox"/> DRILL CUTTINGS <input type="checkbox"/> SAND

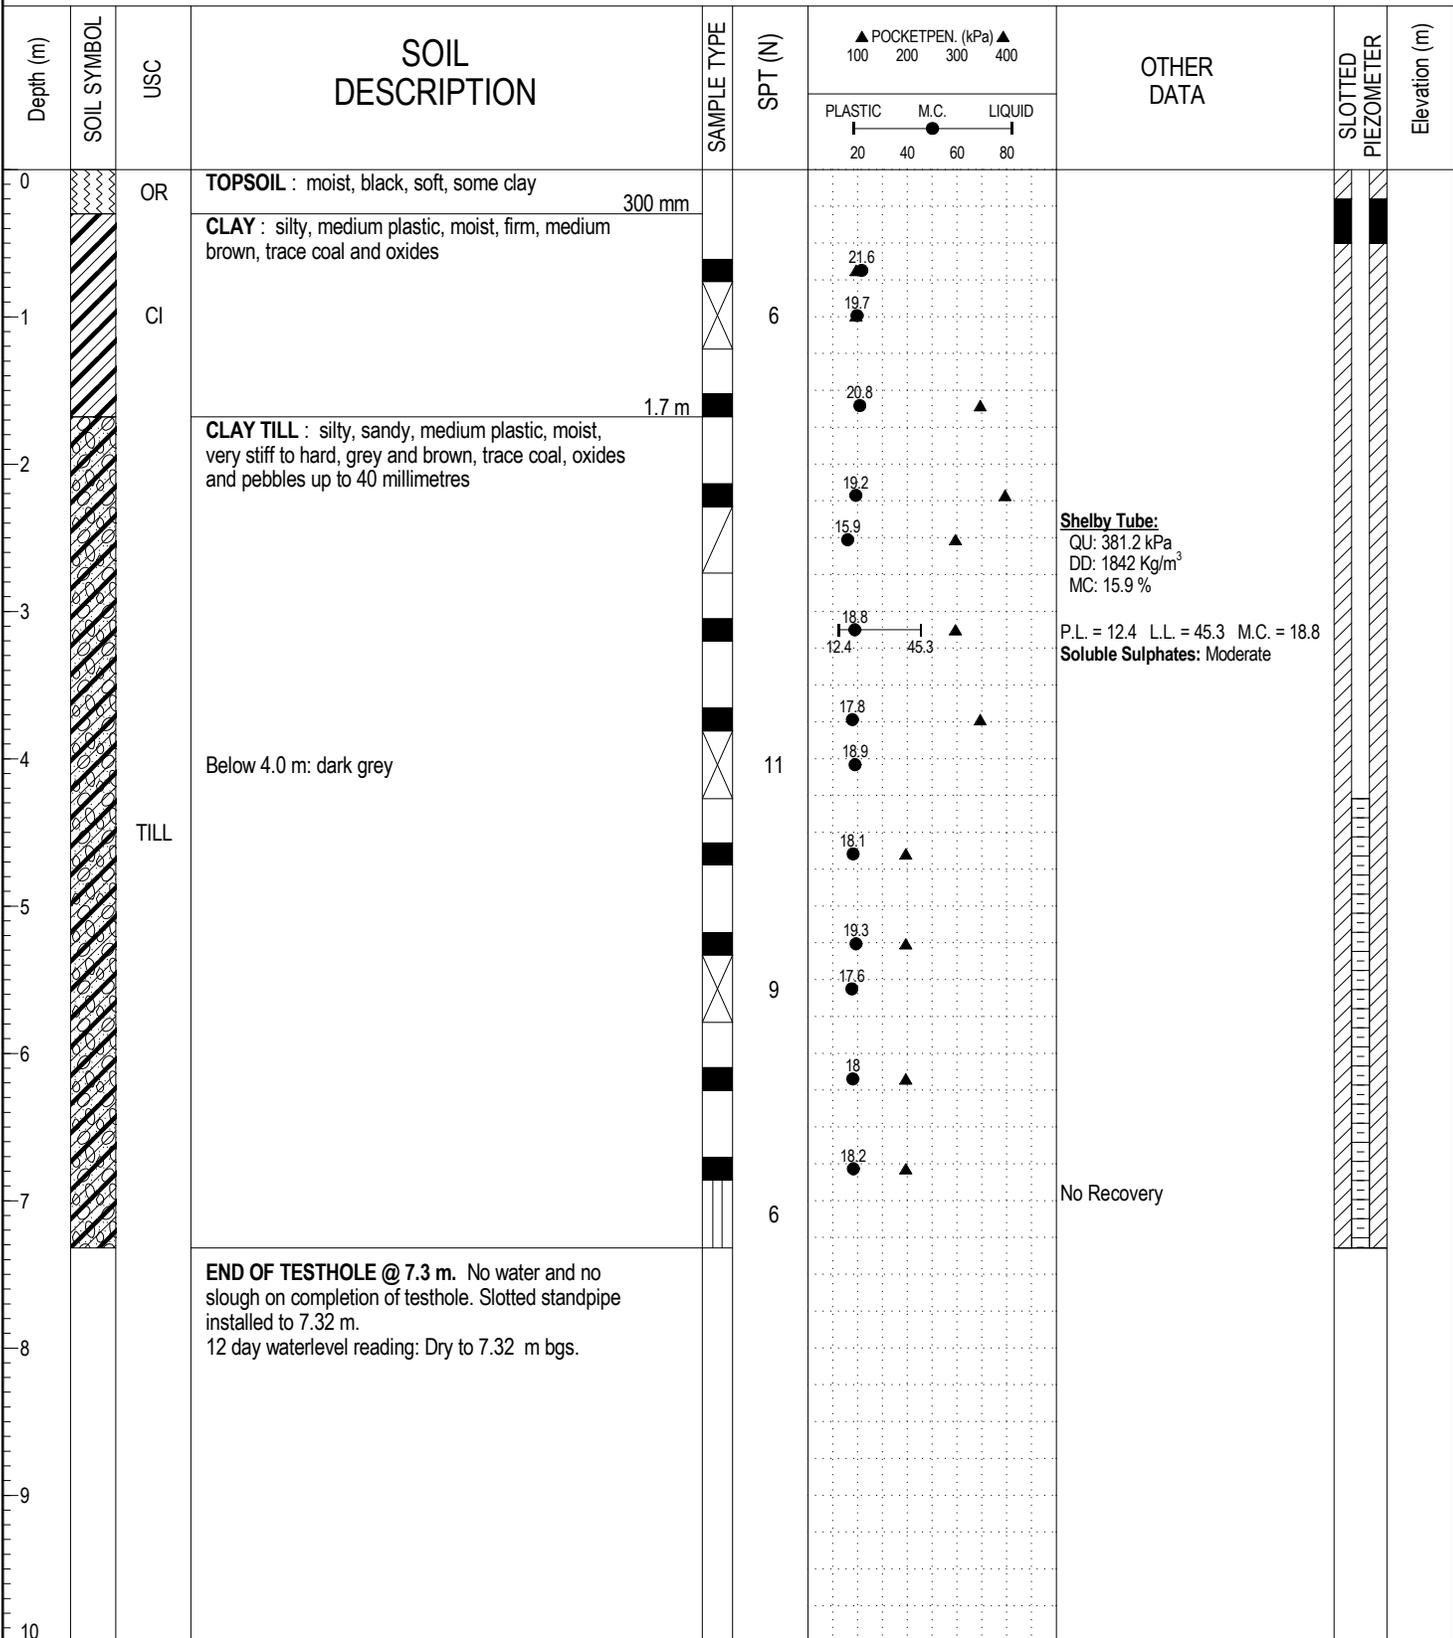
LOGGED BY: Scott MacFarlane
REVIEWED BY: R Evans
Fig. No: 07-3

PROJECT: Preliminary Geotechnical Assessment, N1/2 SE 9-51-24-W4M		PROJECT NO: 1166-274	BOREHOLE NO: 07-3
CLIENT: Qualico Developments West Ltd.		DRILL METHOD: Solid Stem Auger	ELEVATION:
OWNER:		LOCATION: As per site plan	
SAMPLE TYPE	<input checked="" type="checkbox"/> SHELBY TUBE	<input checked="" type="checkbox"/> CORE SAMPLE	<input checked="" type="checkbox"/> SPT SAMPLE
	<input type="checkbox"/> GRAB SAMPLE	<input type="checkbox"/> NO RECOVERY	
BACKFILL TYPE	<input checked="" type="checkbox"/> BENTONITE	<input type="checkbox"/> PEA GRAVEL	<input type="checkbox"/> SLOUGH
	<input type="checkbox"/> GROUT	<input checked="" type="checkbox"/> DRILL CUTTINGS	<input type="checkbox"/> SAND

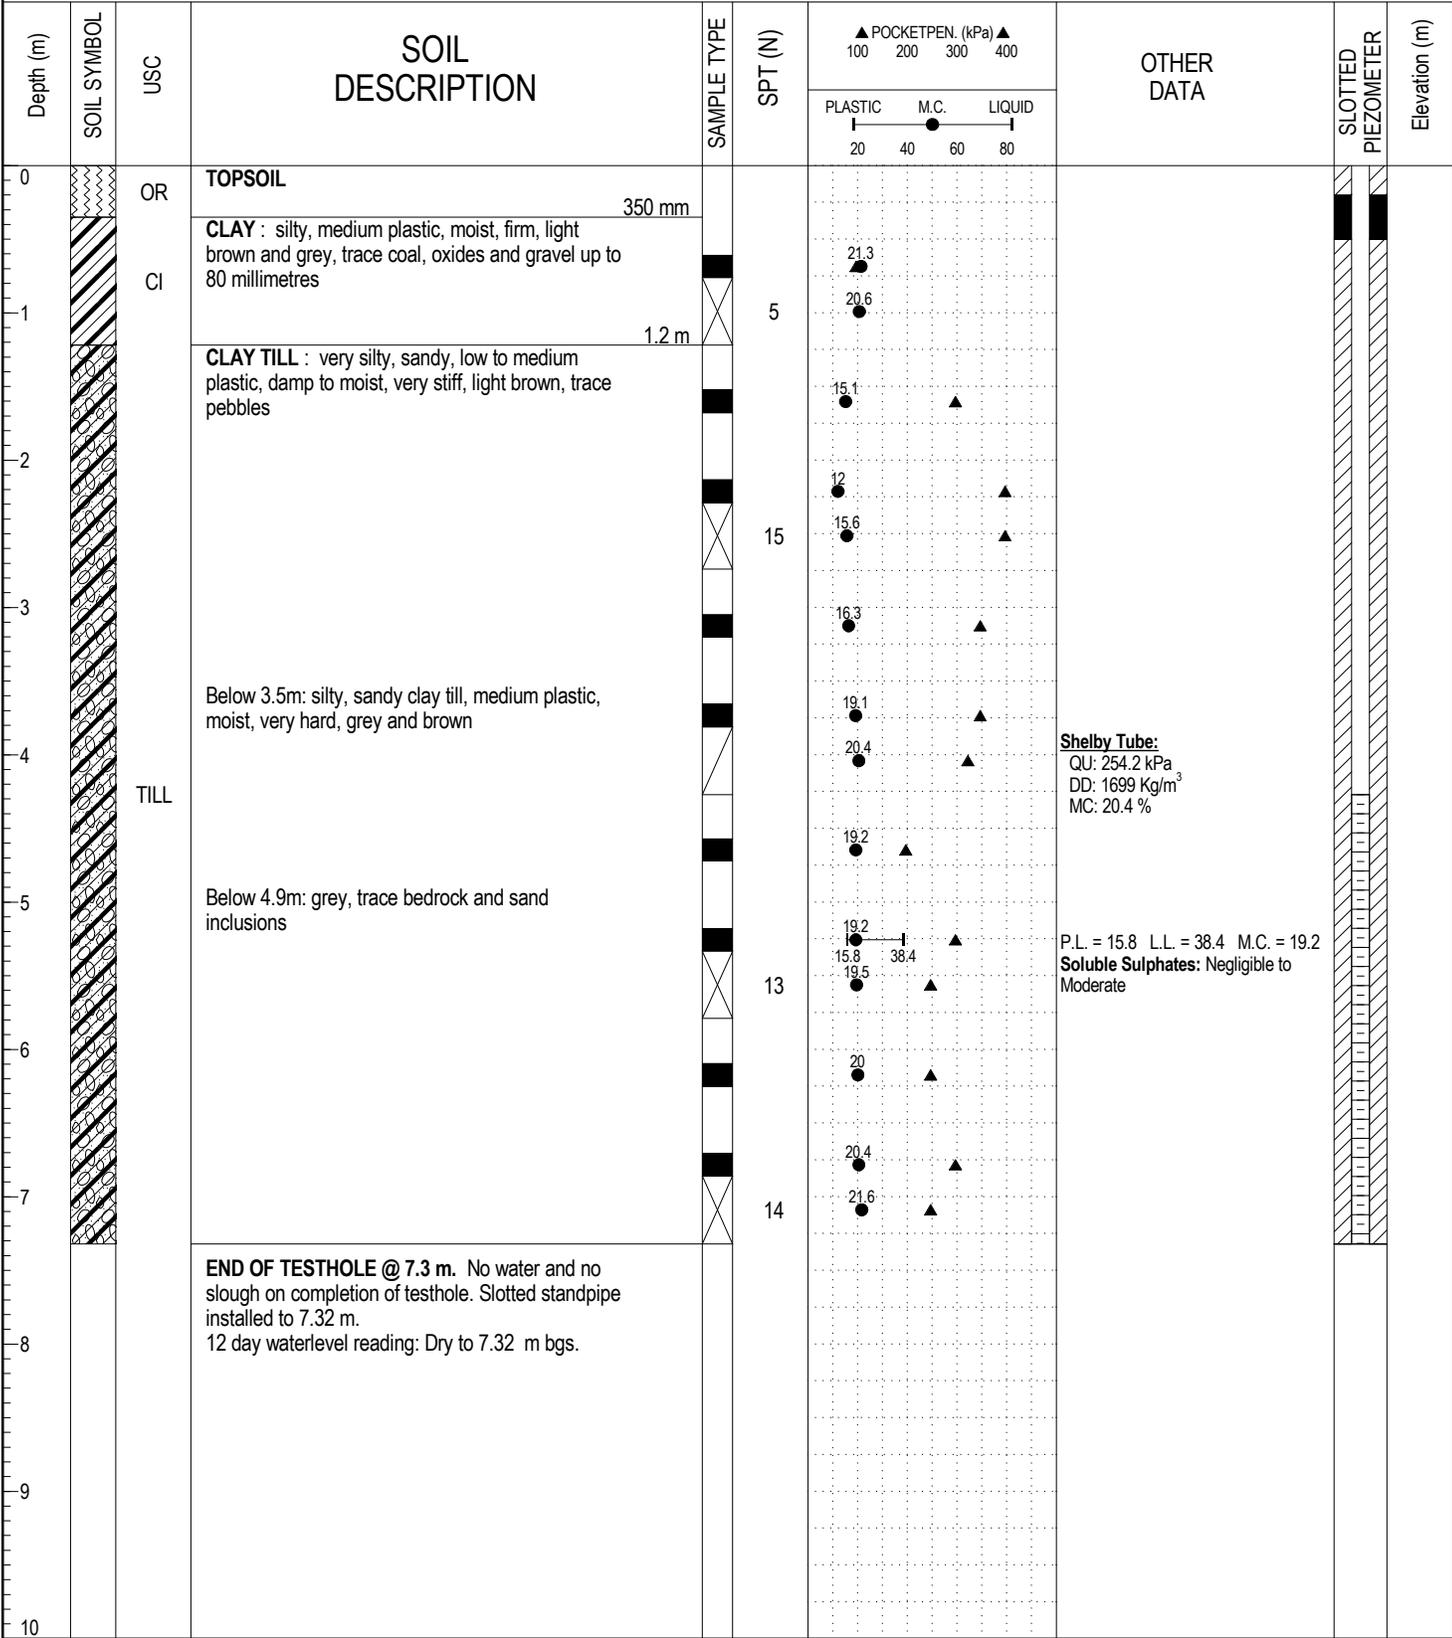
LOGGED BY: Scott MacFarlane
REVIEWED BY: R Evans
Fig. No: 07-4

PROJECT: Preliminary Geotechnical Assessment, N1/2 SE 9-51-24-W4M		PROJECT NO: 1166-274	BOREHOLE NO: 07-4
CLIENT: Qualico Developments West Ltd.		DRILL METHOD: Solid Stem Auger	ELEVATION:
OWNER:		LOCATION: As per site plan	
SAMPLE TYPE	<input checked="" type="checkbox"/> SHELBY TUBE	<input checked="" type="checkbox"/> CORE SAMPLE	<input checked="" type="checkbox"/> SPT SAMPLE
	<input type="checkbox"/> GRAB SAMPLE	<input type="checkbox"/> NO RECOVERY	
BACKFILL TYPE	<input checked="" type="checkbox"/> BENTONITE	<input type="checkbox"/> PEA GRAVEL	<input type="checkbox"/> SLOUGH
	<input type="checkbox"/> GROUT	<input checked="" type="checkbox"/> DRILL CUTTINGS	<input type="checkbox"/> SAND
